EXECUTIVE SUMMARY

As part of the Pearl Harbor Integrated Natural Resources Management Plan, the Pacific Division, Naval Facilities Engineering Command has tasked the U.S. Army Corps of Engineers Honolulu District to delineate the wetlands of Pearl Harbor on specific U.S. Navy installations. The delineations were performed in accordance with the Corps of Engineers 1987 Wetland Delineation Manual and were certified for regulatory purposes by the Corps Honolulu District for five years. This report contains the documentation which went into the delineation process.

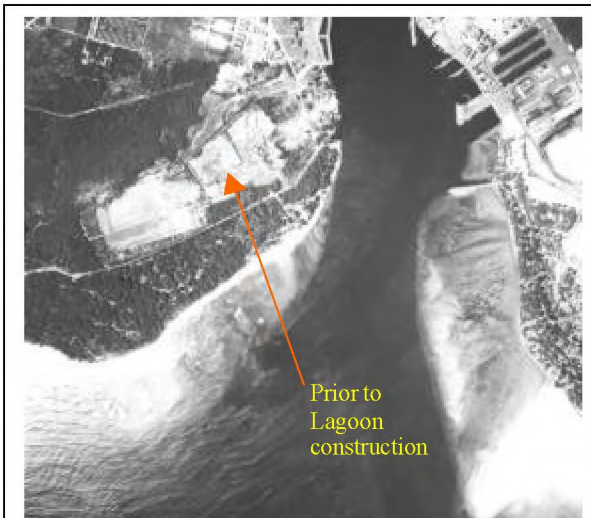
Figure 4 - Aerial photograph dated September 1950 by R.M. Towill Corp.

One of the most prominent features of the Iroquois Point Naval Housing area is the manmade Iroquois Point Lagoon which was created by excavation of dry land. Figure 4 is an aerial photograph taken by R.M. Towill Corporation in September, 1950 prior to the development of the housing units which currently occupy the property. Figure 5 is an aerial photograph taken by R.M. Towill Corporation on June 13, 1962 showing the excavated lagoon and construction of housing units.

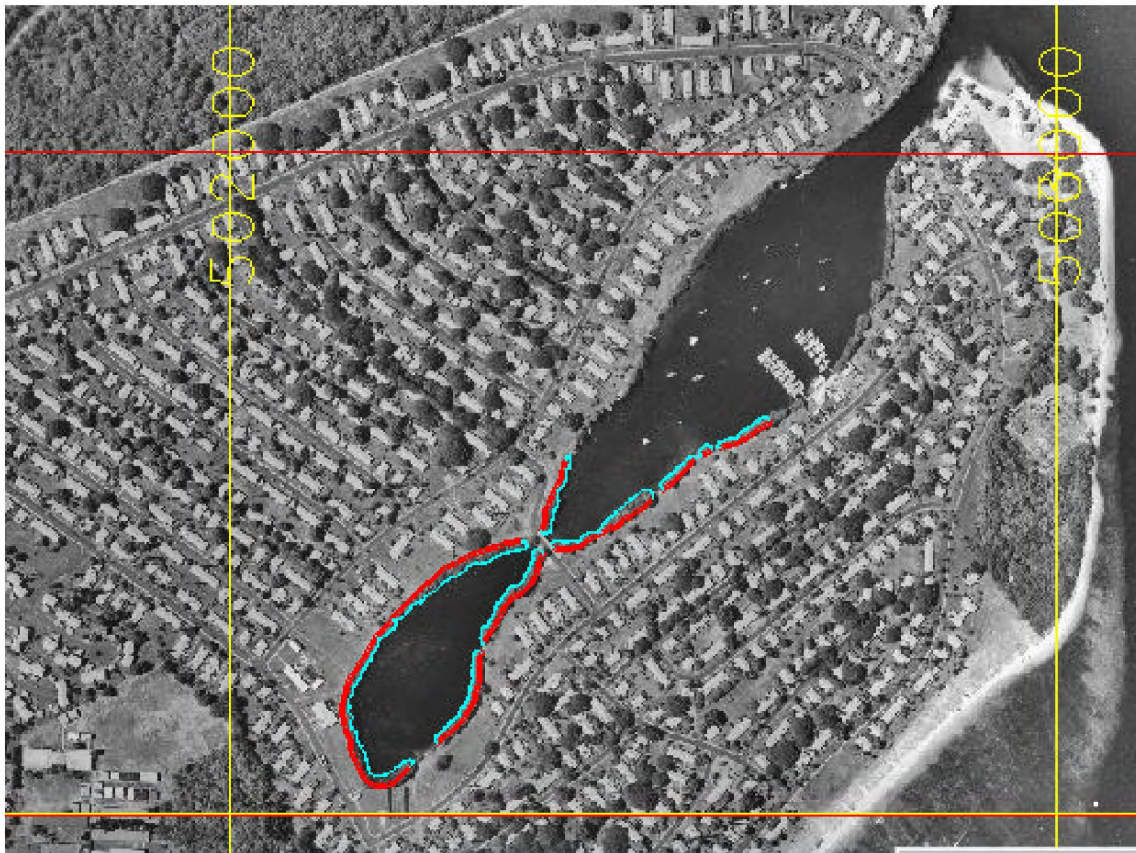
Figure 6 - Coastal wetlands at Iroquois Point Lagoon.

In the forty years since construction of the lagoon, sediment from erosion and runoff has accreted along the shoreline. Organic matter such as leaves also contribute to the sediment load. Based on sample points and field observations, the shoreline areas at the lagoon are considered wetlands as shown in Figure 6 below.

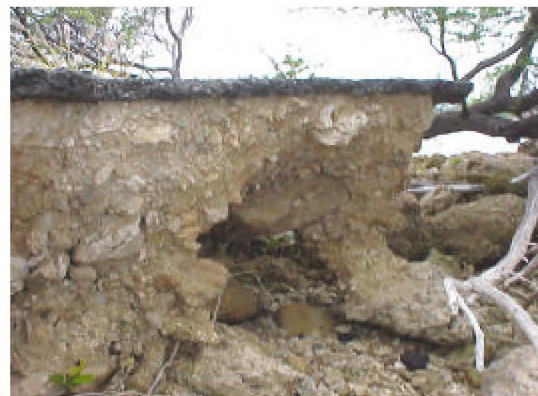
Figure 7 - Erosion at entrance channel of Iroquois Point Lagoon.

However, the reef material and topography contribute to the lack of wetland hydrology and soil indicators on most of this shoreline. For most of this shoreline, wetlands were found in discrete isolated pockets. The shoreline is either too rocky or too exposed preventing large colonies of mangrove from becoming established.

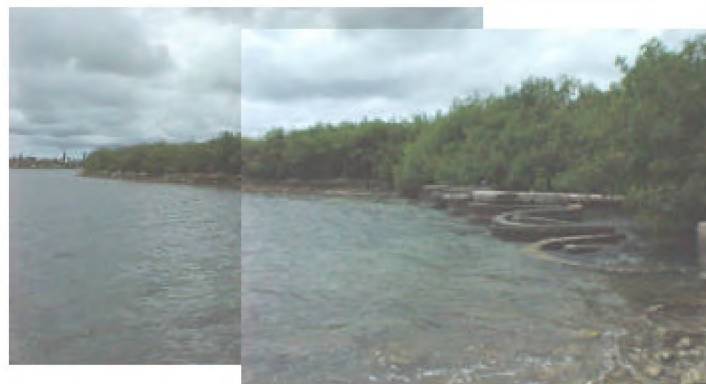
Figure 8 - Loko Okiokiolepe. View towards Pearl Harbor entrance channel. Wetland #2100102206

The seaward most fishpond is called Loko Okiokiolepe (Figure 8) and is located just to the east of the training area called Cdr Heinz Ordnance Training Facility. The fishpond can be accessed by going around the fence at the training facility or by going through the access road on the west side of the pond. The back portions of the pond are tidally influenced

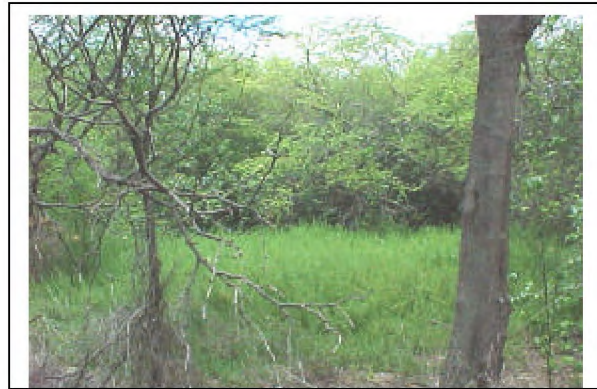
Figure 9 - Pickleweed patch behind mangroves at Loko Pamoku fishpond. Wetland #2100102207

just past the secured bunkers. This fishpond is also colonized by mangroves with patches of pickleweed behind it (Figure 9). The soil in this area is a dark odoriferous muck.

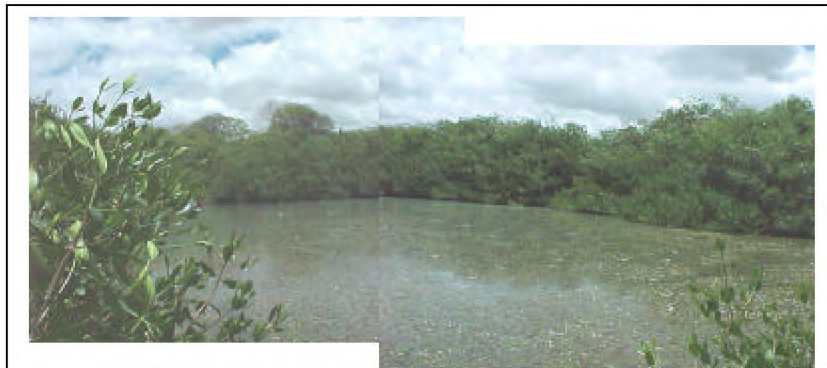
Figure 10 - Interior of unnamed impoundment looking towards harbor. Wetland 2100102213

The third impoundment is shown on Figure 10 and is not identified in the Bishop Museum map (Sterling and Summers, 1978) nor on the State Historic Preservation Division's fishpond map. This pond is located off of the former officers' quarters located at the end of B Avenue and may have been constructed by the military. Old maps refer to the headland at this location as Nichols Point. An interior wall separates the pond into two cells. The homes and structures there have all been removed but the paved road and some of the sidewalks are still intact. Because this pond is not mapped, and most of the structural features are concrete, it is not known whether this was a historic fishpond whose walls were covered with concrete or whether it was built entirely by the military from scratch. A search of the permit logs did not provide any clues as to who built/improved the pond walls or when the improvements took place.

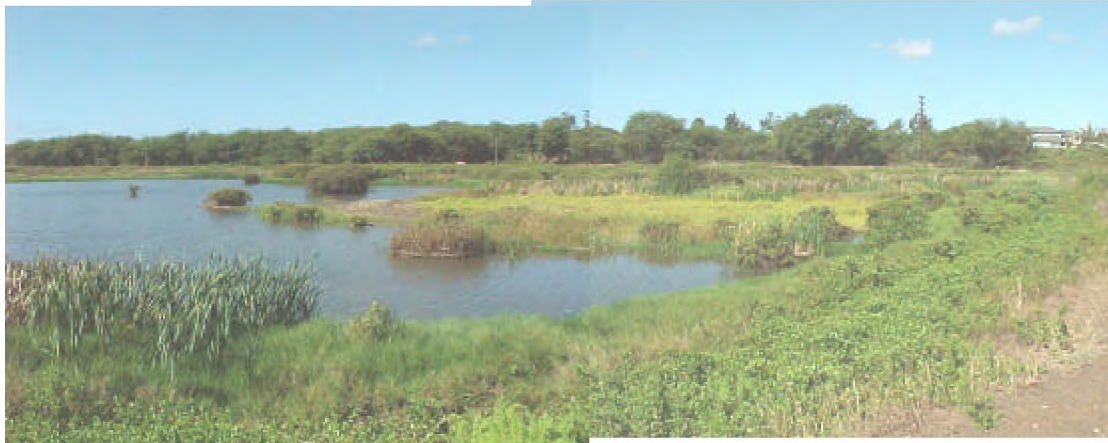
Figure 12 - Photograph of the east pond of the Honouliuli unit, PHNWR. Wetland #2100103165

On 13 August, 1999, we were escorted to the Honouliuli unit by Mr. Michael Silbernagle of the USFWS. The refuge is split into a west pond and east pond. The interior of the west pond contains hydric vegetation such as cattails (*Typha latifolia*), knotgrass (*Paspalum distichum*), spike rush (*Eleocharis sp.*), *makai* (*Bolboschoenus maritimus*). Indian fleabane covers some of the islands and is also found on the edges of the ponds. Mr. Silbernagle indicated that the cattails are favored for nesting by the coot and moorhen.

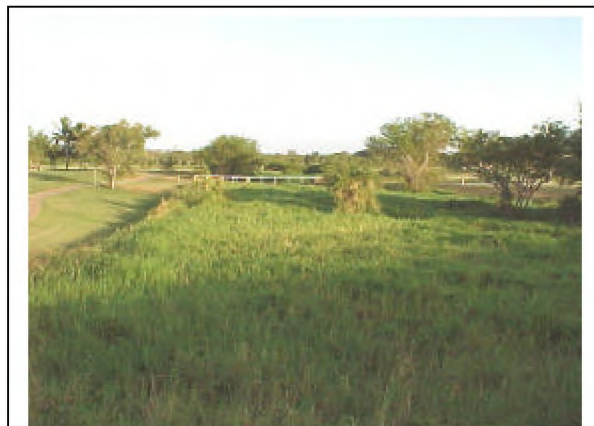
Figure 13 – Photograph from Fort Weaver Road of stream at West Loch golf course. Wetland #2100103174

The West Loch Golf Course is a part of the City and County of Honolulu municipal golf course system. A small stream traverses the golf course (Figure 13). The stream is choked with California grass (*Brachiaria mutica*), water hyacinth (*Eichhornia crassipes*), and cattails. During heavy rains, much sediments are trapped in the waterway and the adjoining fairways are occasionally flooded. Ponds are also interspersed throughout the golf course. The driving range is a pond which golfers hit floating balls into its waters.

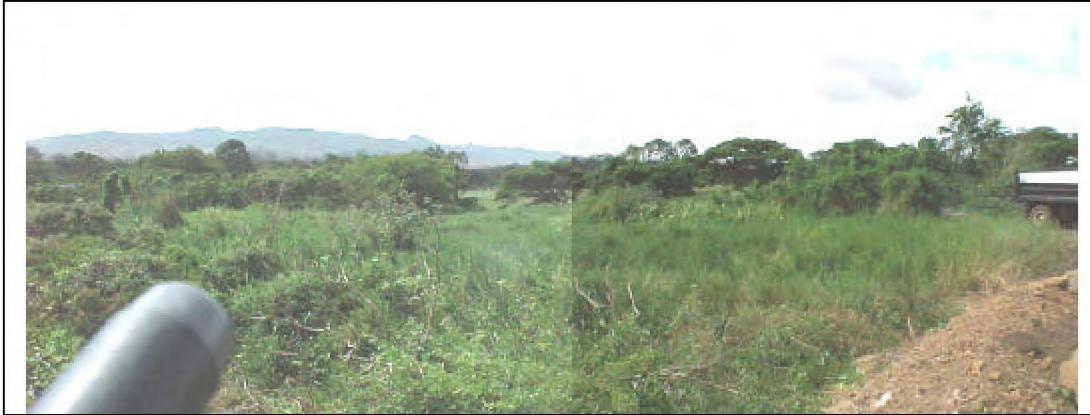
Figure 16 - Kahua Meat Company wetland, Honouliuli. West Loch Golf Course in background. Wetland #2100103167

Located at the intersection of Old Fort Weaver and Fort Weaver Roads in Ewa, Kahua Meat Company is a slaughterhouse that processes livestock. Some of their sewage is treated in this pond adjacent to West Loch Golf Course's 10th tee and Kahua Nursery. The interior of the pond is dominated by California grass. Cattail and duckweed (*Lemna sp.*) are also found here. Indian fleabane, *milo*, and castor bean (*Ricinus communis*) are found on the edges of the wetland.

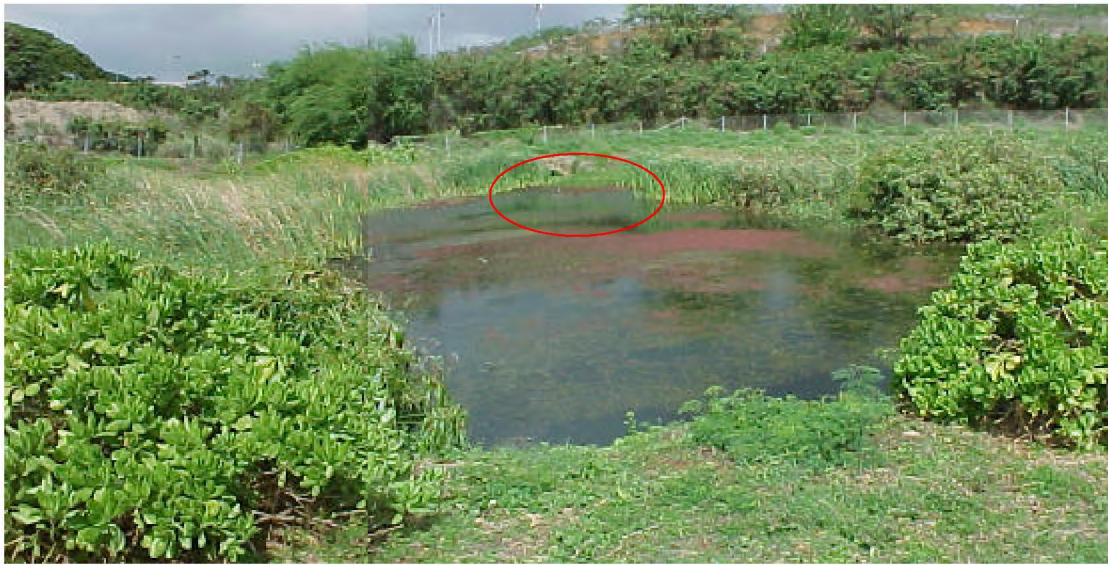
Figure 19 - West side of Kolea Cove wetland. Moorhen observed at rear of pond in circled area.
Wetland #2100105285

In July, 1984, DA permit number 1594-S was issued to Okada Trucking Company to construct three storm drain outlets and discharge approximately 15,000 cubic yards of fill into a wetland in conjunction with a housing project. To mitigate for the loss of wetlands, a wetland pond was created at this site. The housing project is on hold but the pond was constructed and is maintained by Kauhale Kai Limited Partnership. The wetland is slightly over an acre in size and is located mauka of the bicycle path beneath Waipahu High School.

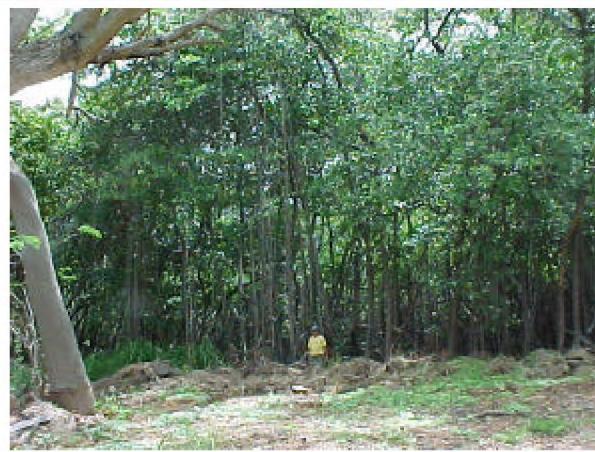
Figure 22 - Mangrove forest on east shoreline of Pearl City Peninsula. Wetland #2100106102

Achyranthes aspera, *Heliotropium procumbens* var. *depressum*, and comb hyptis (*Hyptis pectinata*). As shown in Figure 22, the forest of American mangrove rises 50-70 feet high and extends from the base of the slope to the edge of the shoreline. Remnant patches of sea purslane can be found landward of the forest. These are likely to be the areas of the former backshore areas prior to colonization by mangroves.

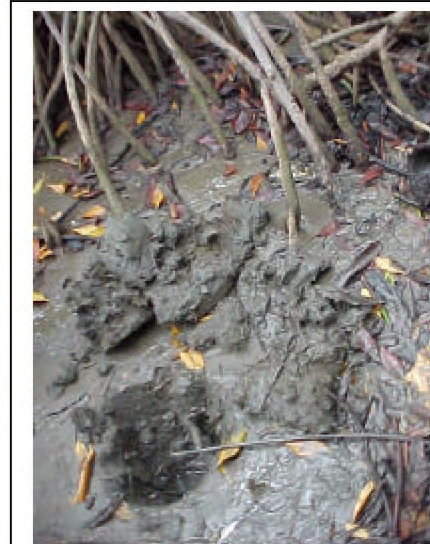
Fig 23 - Soils towards seaward edge within mangrove forest.

The soils are mapped as Pearl Harbor Silty Clay and the general description matches what was found in the field. The soil is dense and firm. We did not sink as we walked through the forest. The first several inches of the soil is mostly roots and peat. Beneath this horizon, the soils were gleyed clay (Figure 23). See data sheets for more information.

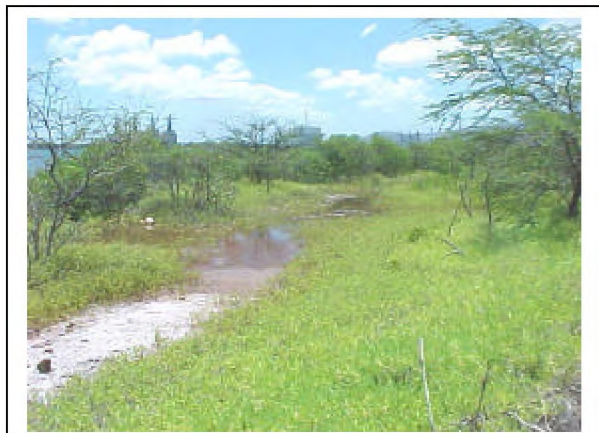
Figure 25 - photo taken at high tide, 25 Aug 1999.
Wetland #2100106090

The debris line contained flotsam such as slippers, balls, seed pods, and paper cups typically found at other tidal mangrove forests in Pearl Harbor. A test pit was dug during low tide on 14 Jul 1999 and the red and brown soils contained rocks and gravel. The water table was 13 inches below ground level. The site was visited during high tide on 25 Aug 1999 and the area was inundated. Thus it appears that the soils from the edge of the fill are mixing with the soils in the inundation area and an atypical situation is occurring. Based on the inundation and the prevalence of hydric vegetation, the area is functioning as a wetland and meets the definition of a wetland.

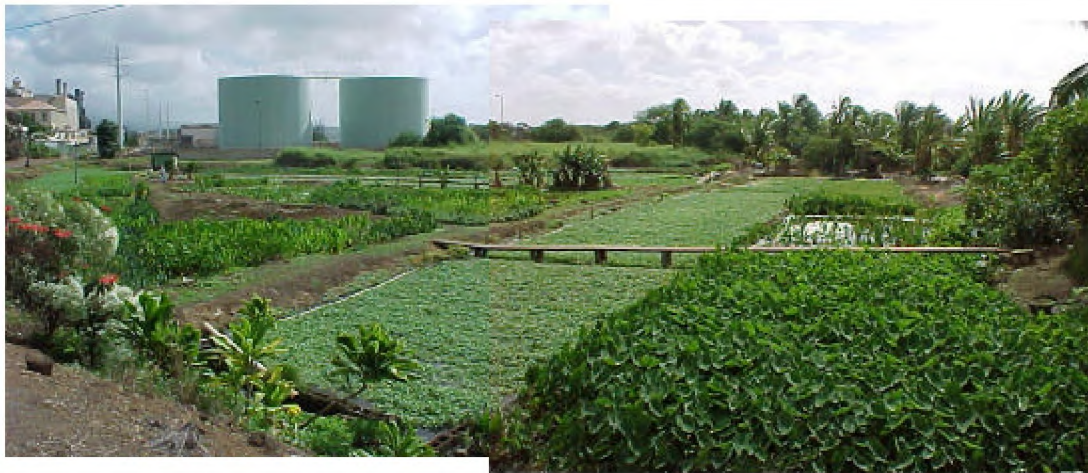
Figure 27 - Agricultural fields at Pearl City Peninsula. Wetlands #2100107256 - 2100107267

Figure 27 below is a photograph of the wetlands adjacent and south of the bicycle path. HECO's Waiau power plant is in the back left. Taro and watercress were seen in these ponds.

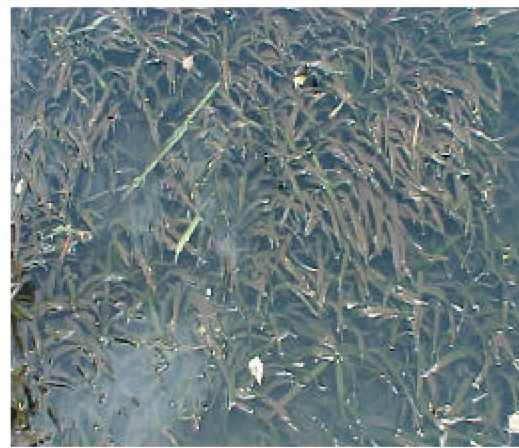
Figure 30 - *Vallisneria americana* found near outlet of wetland near Kamehameha Highway.

This wetland in Waiau is bounded by residential homes along Kuleana Place, Kaulike Drive, Kamehameha Highway, and Zippy's restaurant (Figure 29). The Waiau wetland is drained by three CMP arch culverts beneath Kamehameha Highway which empties into an open channel that crosses the east side of the Waiau power plant parcel before entering East Loch. An aquatic plant (*Vallisneria americana*, Figure 30) covers a portion of the pond near the outlet.

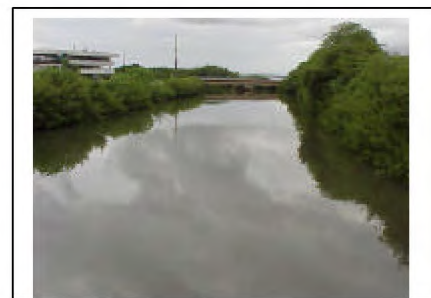
Figure 31 - Waimalu Stream. View from Kamehameha Highway looking downstream towards bicycle path.

The edges of Waimalu Stream are colonized by American Mangrove from its mouth up to the Kamehameha Highway bridge. The west side of the park is adjacent to a City and County baseyard and the Neal Blaisdell park. There are several large

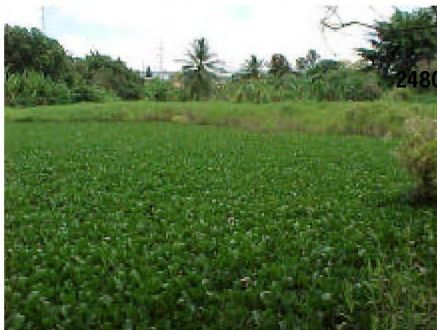
Water hyacinths dominate the lower section of the marsh. Upstream is California grass.

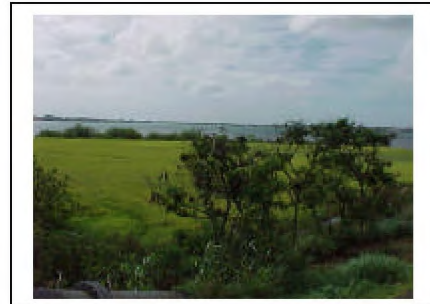
Figure 32 - Batis field at mouth of Waimalu Stream. Wetland #2100107140

A large patch of pickleweed has colonized the mudflat on the delta formed at the mouth of Waimalu Stream (Figure 32). Indian fleabane, *kiawe*, *milo*, American mangrove, and California grass also occur at edges of this patch

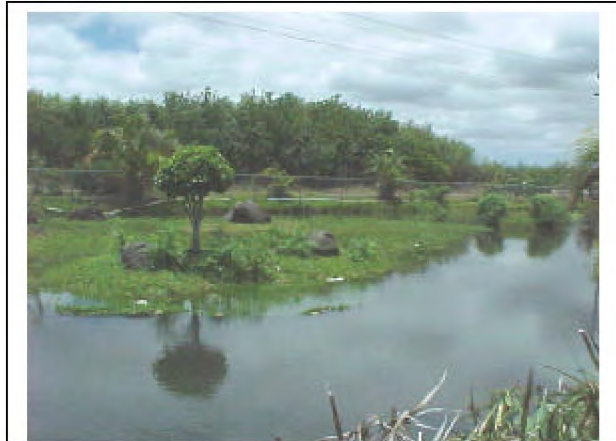
Figure 35 - Pearl Kai Shopping Center mitigation site. Bicycle path is behind the fence. Wetland #2100107042

Department of the Army permit number PODCO 1987 was issued to the developer of the Pearl Kai Shopping Center for the placement of fill in the wetlands. To account for the flood storage wetland function, the shopping center's building closest to the stream was built on posts. As additional mitigation for placing fill in the wetland, mangroves were removed and a wetland pond and nesting island were constructed (Figure 35). Wetland vegetation at the site area includes *Cyperus difformis*, *Paspalum conjugatum*, *Cyperus polystachyos*, water hyssop, California grass, umbrella sedge, and mangrove. Two large dogs were seen on or near the site in two separate visits.

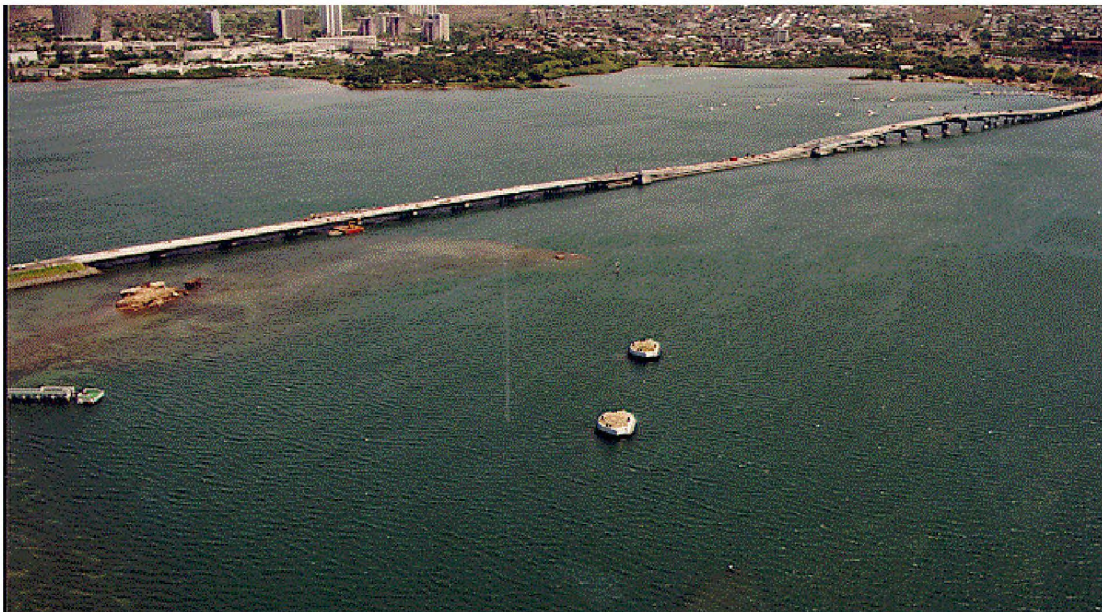
Figure 40 - Admiral Clarey bridge and U.S.S. Arizona memorial.

The most prominent structure on the island is the 4,672-foot-long fixed bridge with a floating, retractable 930-foot-long pontoon (see figure 40). The Admiral Clarey bridge connects the main portion of Oahu to Ford Island and was opened in 1998. An engineering landmark, the structure enables vehicular traffic and allow the development of Ford Island. Prior to the bridge, a ferry system was used to provide access to the island.

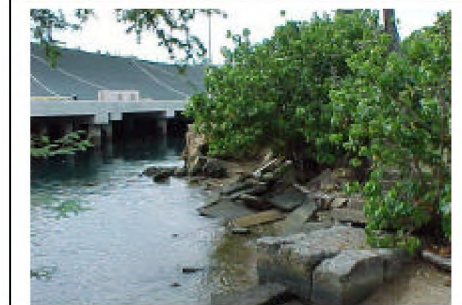
Figure 42 Segment 1

Segment 1 North of Pier F-5, there are several vacant homes. In this area, the shoreline is an eroded limestone face approximately 6-8 feet high. Shoreline vegetation includes *milo*, coconut, *koa haole*, and *kiawe*. Construction debris including slabs of concrete, has been placed along the shoreline as erosion protection (Figure 42).

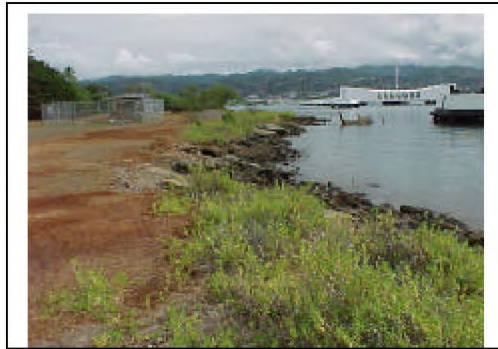
Figure 43 Segment 2

Segment 2 From Pier F-5 north to the Arizona memorial, there is a low level area one to two feet above water level. A thin layer (one to two inches) of red soil has been placed atop old fill and is grassed in the upper areas (Figure 43). The area closest to the shore appears to be infrequently flooded as evidenced by salt crystals and the lack of vegetation. There are no trees and pickleweed, *milo*, and *kiawe* are the dominant vegetation along the shoreline. The soils are fill material and were very dry and hard during the visits. Thus this area is not a wetland.

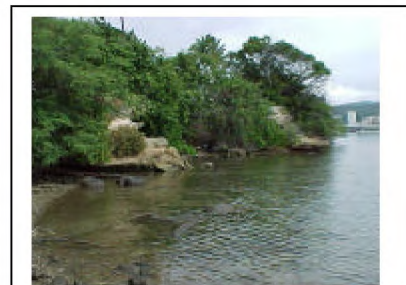
Figure 44 - Segment 4

Segment 4 The shoreline in this segment (Figure 44) intersects with the base of the bank which extends from the officers' quarters to the Ford Island Bridge. This is the highest point on the island, which has eroded due to its exposure to the prevailing offshore winds. The shoreline is primarily coralline in this area and the steep slope precludes the formation of wetland conditions. Vegetation includes sourbush, *koa haole*, *kiawe*, banyan, and coconut. The shoreline here is similar from this point to the bridge.

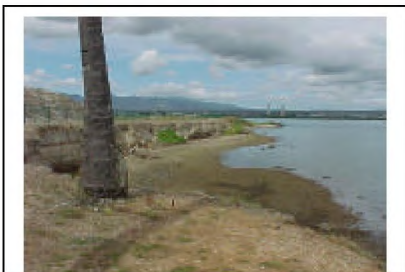
Figure 45 - Segment 5

Vegetation includes sourbush, *koa haole*, *kiawe*, banyan, and coconut. The shoreline here is similar from this point to the bridge.

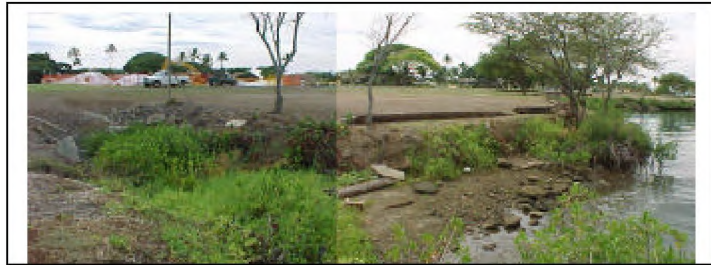
Figure 46 - Segment 7

Segment 7 The areas between Piers F12 and F13 appears to be filled by coralline material and concrete rubble (Figure 46). The land is level and approximately 6-10 feet above the water surface. Concrete rubble is exposed on the very steep bank. Judging from the monkeypod, and *kiawe*, it

appears that this area was built up and leveled many years ago. Mangrove and pickleweed are abundant on the shoreline. *Milo* are interspersed primarily near the top of the banks. The vegetation is trimmed and maintained. Similar to the previous segment, this area does not meet the 1987 Corps of Engineers Wetland Delineation Manual wetland criteria due to the lack of hydrology and soils. Like a lot of Ford Island, the hydric vegetation thrives because it has little or no competition in the low rainfall, saline area.

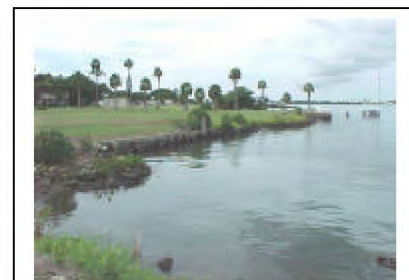
Figure 47 - Segment 8

Segment 8 Between Pier F12 and the U.S.S. Utah, the shoreline vegetation is primarily pickleweed. There is the remnant of an old pier, a short bulkhead and construction debris in the area. Also of interest are the mangroves growing in the Utah.

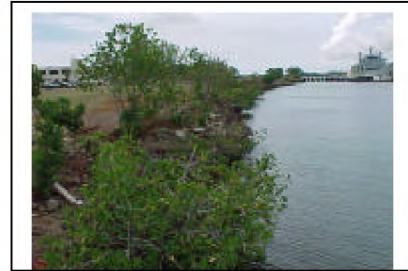
Figure 48 - Segment 9

Segment 9 Between the U.S.S. Utah and Pier F10, the vegetation is primarily *milo*, and *kiawe* (Figure 48). There is heavy construction debris along the shoreline.
